Re: Site Visit – June 4th, 2017
Old Longview Lake Dam and Spillway
Lee's Summit, MO
Olsson Project No. 017-0305

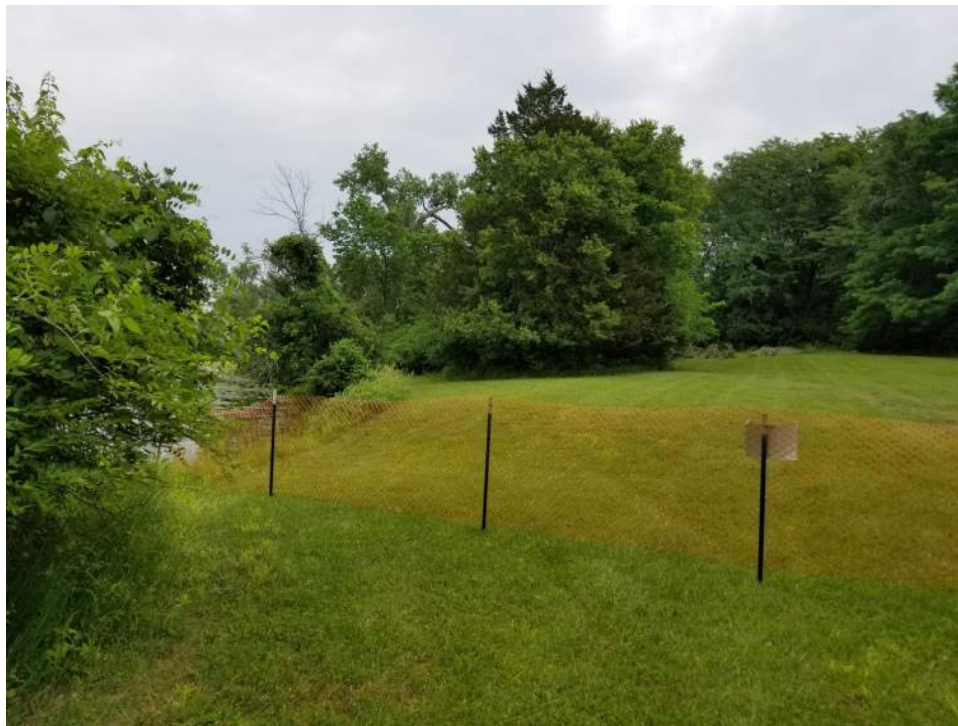
As requested, Olsson Associates (**Olsson**) visited the project site on Monday June 4th, 2018 to observe the existing condition of the Old Longview Lake Dam and Spillway. We observed construction safety fencing on both the east and west sides of the dam as shown in the photograph below.

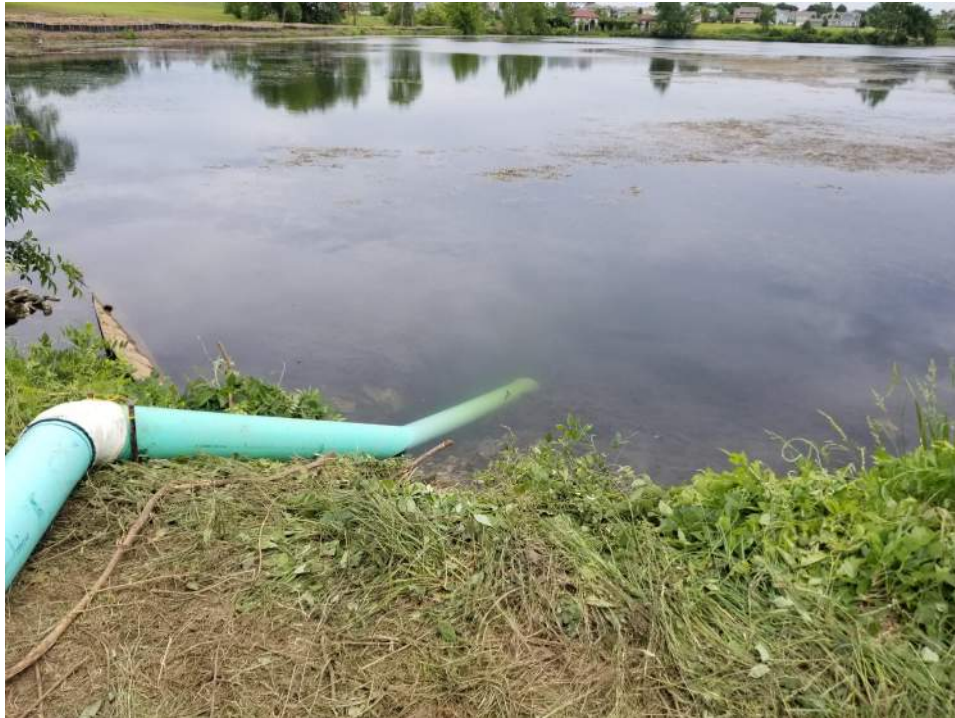
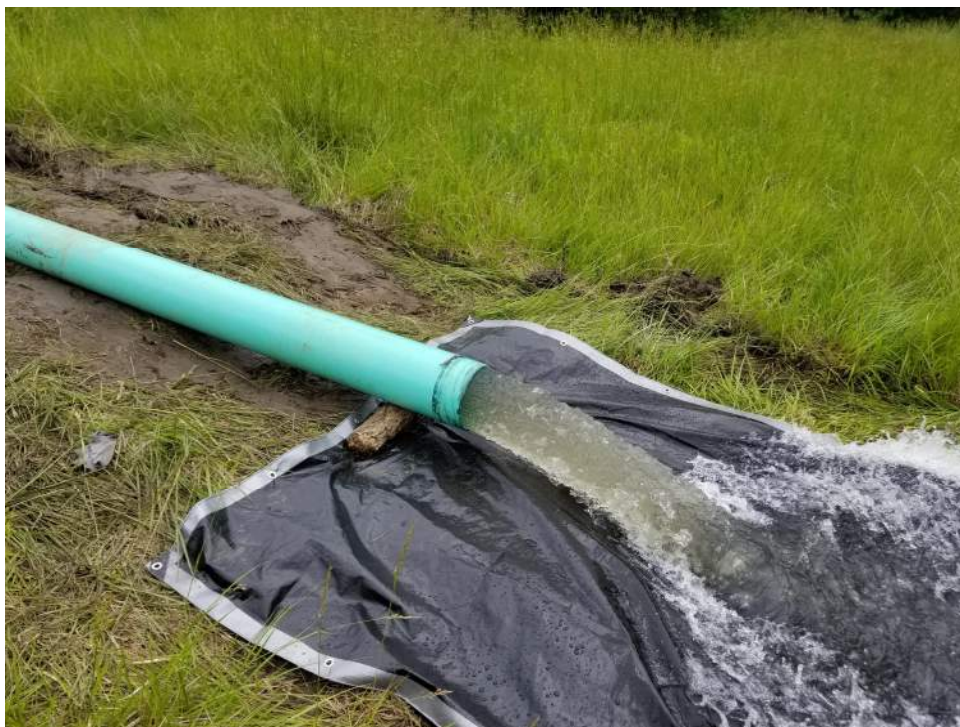
In addition, we observed a syphon pipe set up to draw down the lake. The pipe was around 3 to 5 feet below the water surface. The pipe extended over the dam and extended near the toe of the slope of the dam. The syphon pipe is shown in the following photographs.

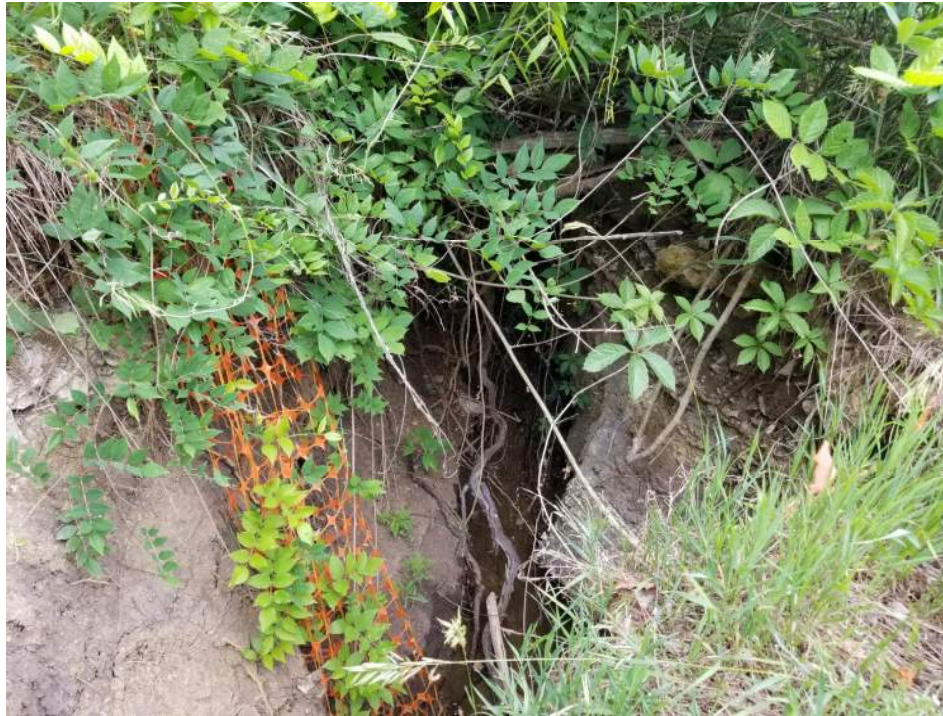
A small amount of water was still flowing through the eroded area on the west side of the dam. Visually, the dam, spillway and erosion channel do not appear to have changed since our previous visit. We have included a photograph of the erosion below.
