**FIELD TEST EVALUATION  
MINE REMEDIATION AT  
STREETS OF WEST PRYOR  
LEE'S SUMMIT, MISSOURI**

**STREETS OF WEST PRYOR, LLC  
OVERLAND PARK, KANSAS**

**SEPTEMBER 1, 2021**

**J035637.02**

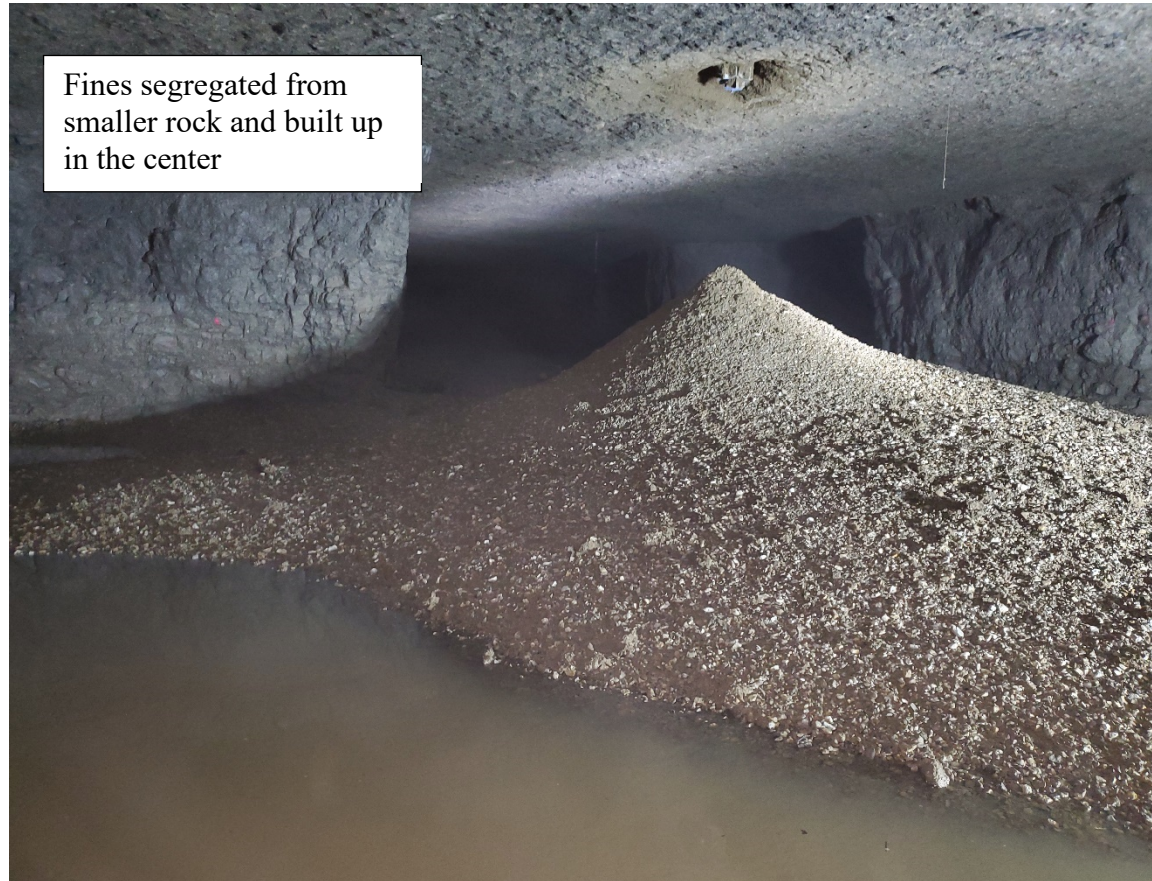
There was clay mixed in with the smaller rock which was detrimental to the process. The clay would stick to the spinner and clods formed in the rock pile.

Fines segregated from smaller rock and built up in the center

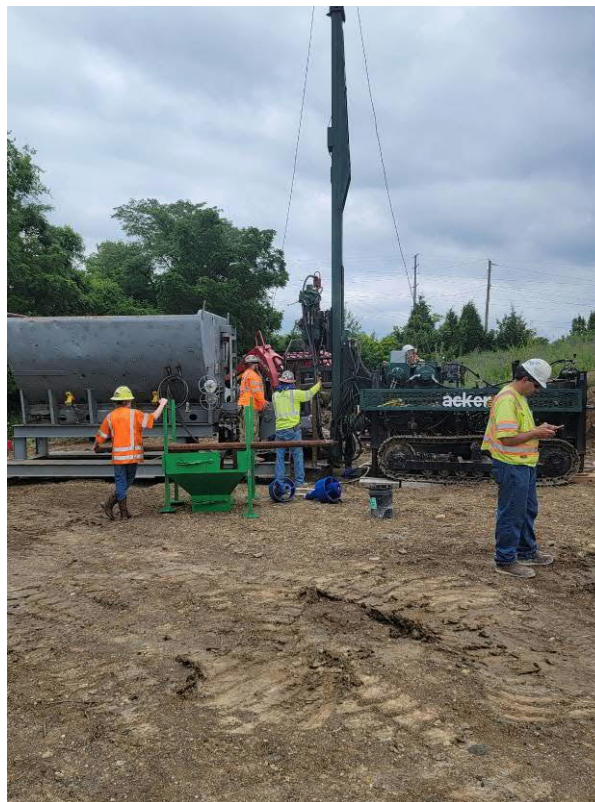
**Description:**  
Surface setup.

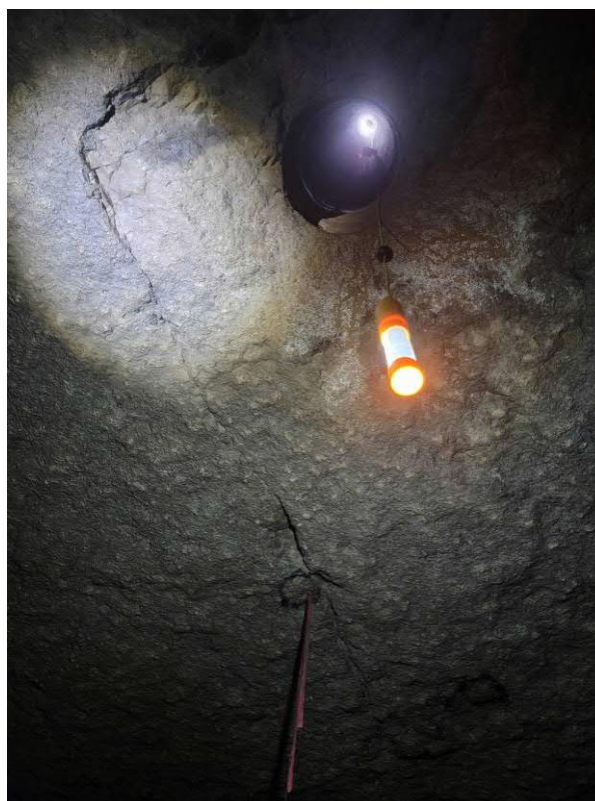
**Description:**  
Bottom of the test hole.

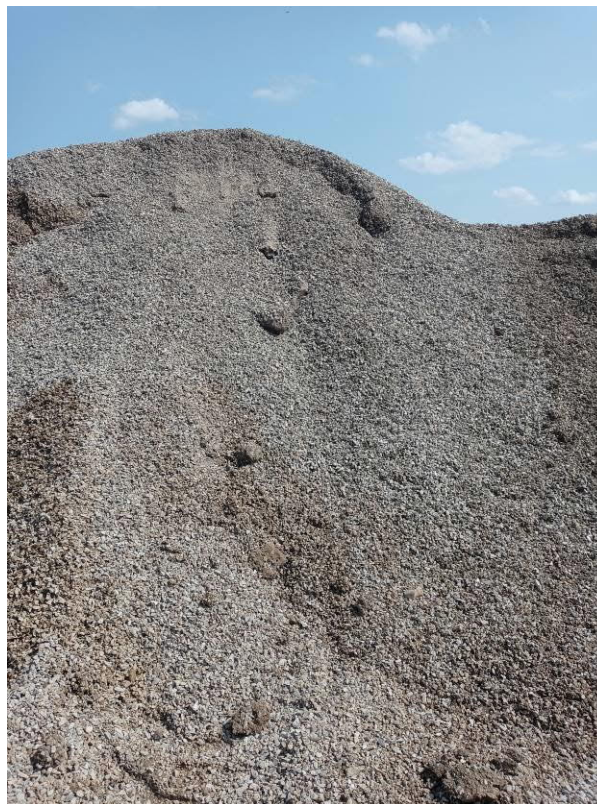
**Description:**  
Stockpile – crushed aggregate.

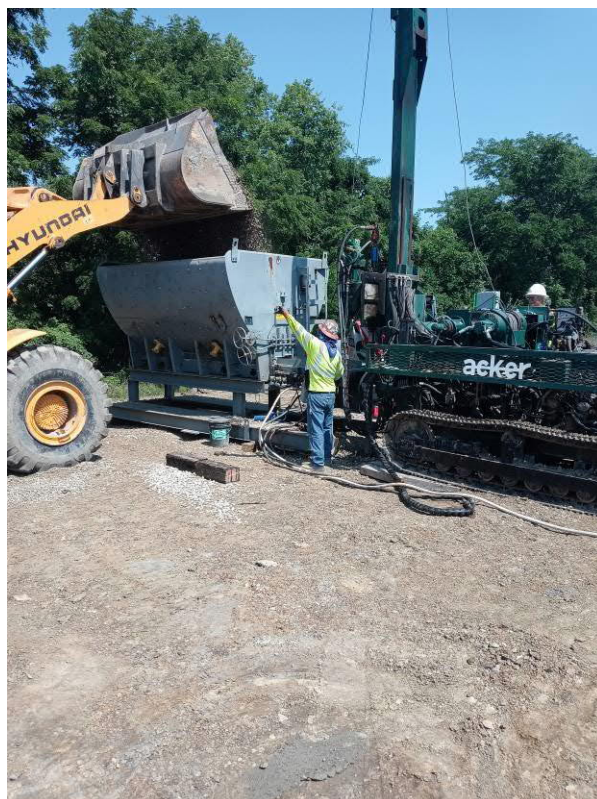
**Description:**  
Loading hopper.

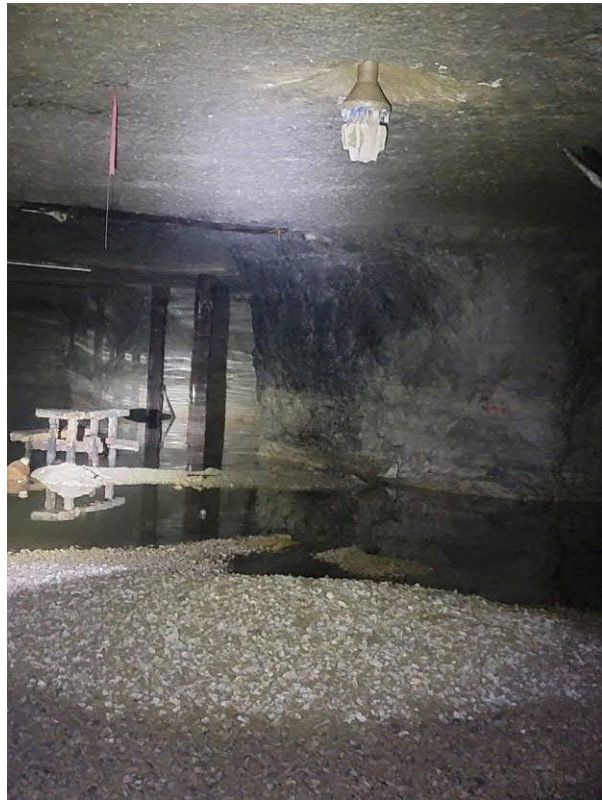
**Discussion:** During placement of the rock it was obvious the cone was flatter at the north and west side of the pile. The slinger was biased to the NW side of the drill hole and from watching the process I am confident the slinger was able to distribute the rock better when the rock was dropped closer to the center of the slinger. The system was designed to work in a 14.5" diameter hole. The vent hole was 19.5" in diameter. I didn't anticipate the hole diameter would make a difference in the performance of the slinger or we would have cased the hole to match the production hole diameter. The extended diameter of the paddles on the slinger is 26" diameter. If centered the slinger would only be 3" larger than the hole diameter reducing its effectiveness.

Initial fill – note bias.

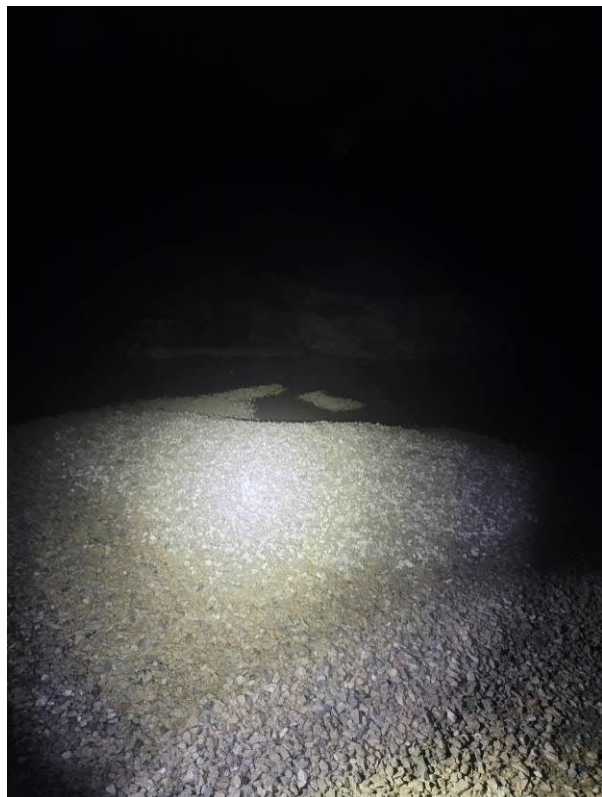
Initial fill.

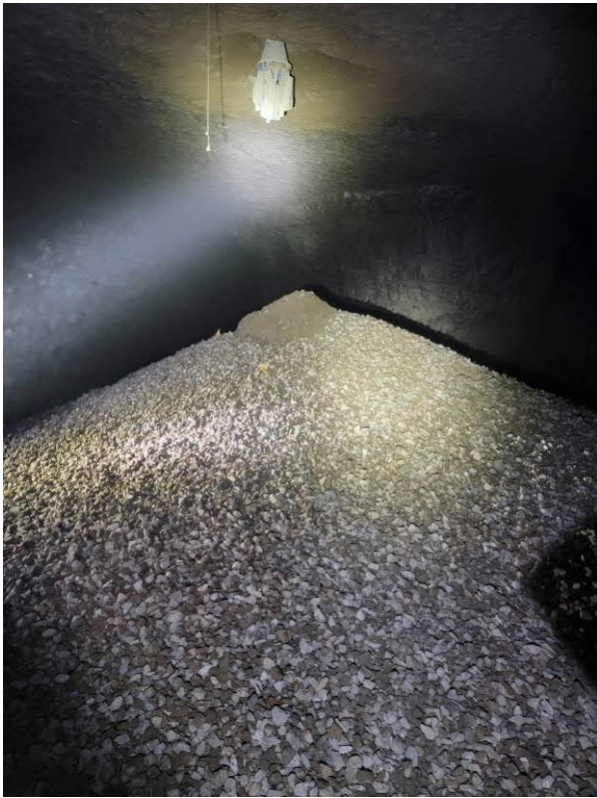
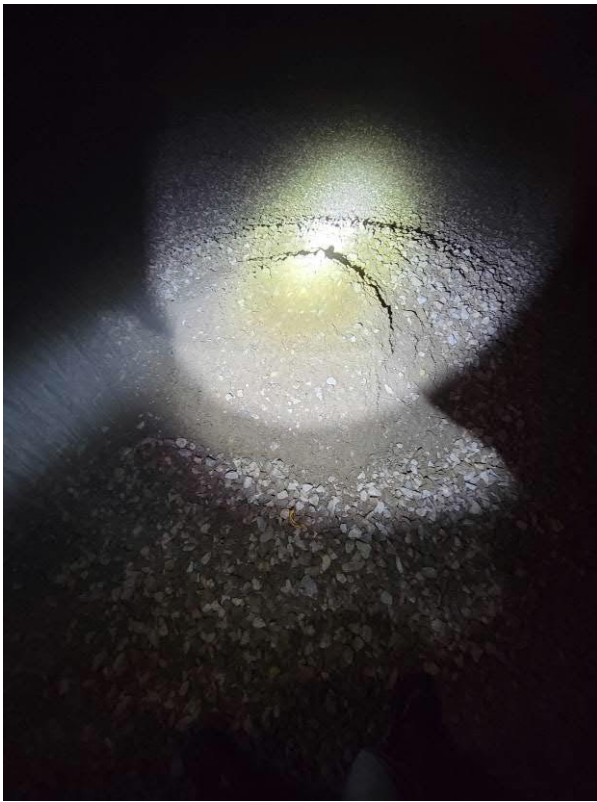
| <p><b>Description:</b><br/>Test fill – mid height.</p> | |
| <p><b>Description:</b><br/>Test fill – mid height.</p> | |

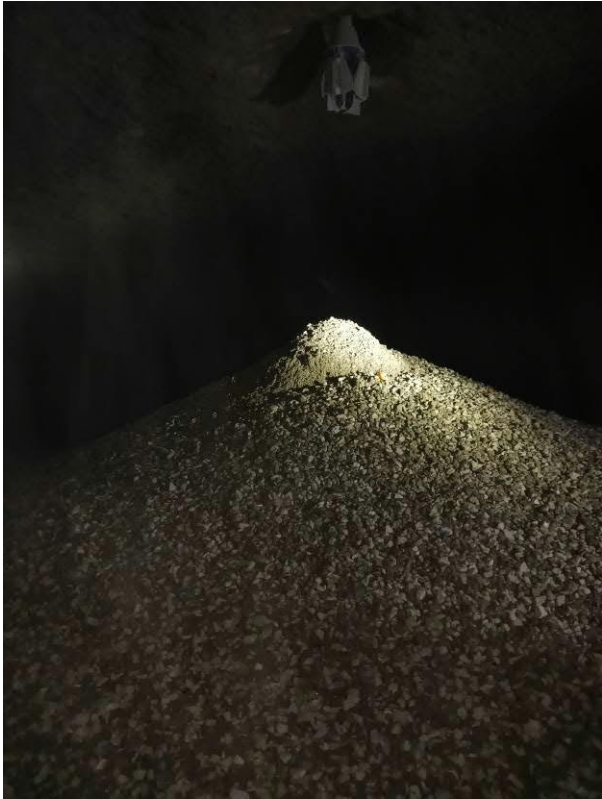
Materials placed ranged in size between 2-inches and ½-inches. The sequence of material placement requires further refinement to verify volumetric fill potential. Filling operations ceased when the fill pile extended to the roof and the slinger could no longer be rotated. The remainder of the shaft was gravity filled with 0.5 inch and 2-inch material. Segregation of materials in the backfill pile were not observed in the test fill. Settlement of the backfill was not observed as of July 23, 2021 by means of visual inspection of the top of fill materials relative to the ground surface.

The resultant pile was measured and had a diameter of approximately 4 to 5 feet against the mine roof. The base of the fill pile extended to the approximate mid-point of the mine room defined by the adjacent pillars. Average distance from the midpoint of the pile slope to the roof is approximately 5 to 10 feet. Based on observation of the rock slinger field test, it appears the rock slinger effectively spreads rock in a relatively uniform manner. The existing shaft did not did not clog nor “choke” during fill placement.

| <p><b>Description:</b><br/>Test fill – completion.</p> | |

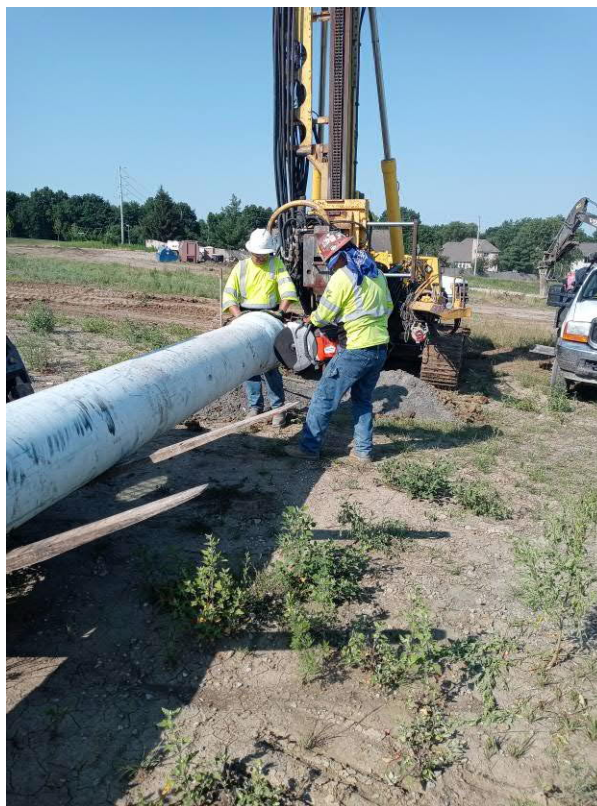
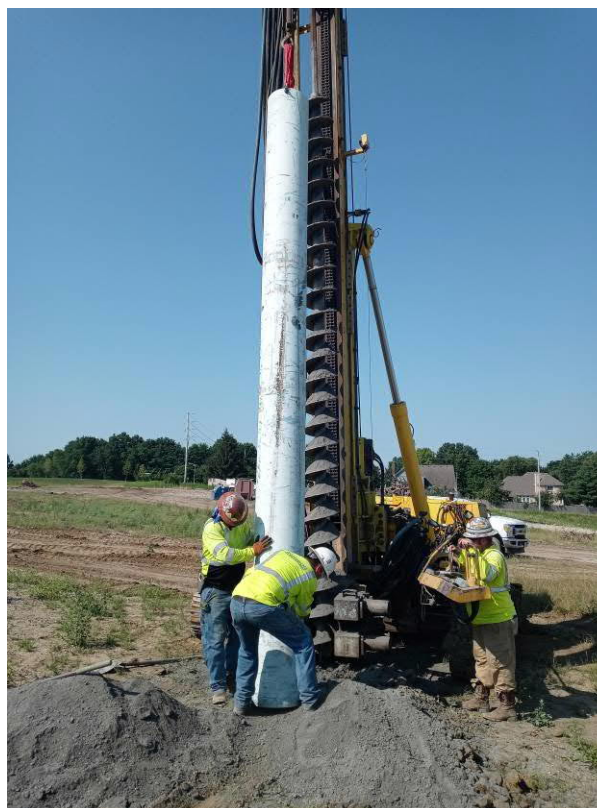
For survey confirmation, three holes were advanced by means of rotary hammer to the mine level. These three holes were planned to confirm the survey and then to be used as production holes. These holes are designated A-7, A-11 and A-13 and were drilled at the locations the Figure. Measurements at the mine level were taken by Geotechnology and BHC, Inc. (BHC) (project surveyor) to evaluate the proximity of the holes to the center of the mine room. Field measurements and observations indicated that the holes were not located in the center of the rooms and were offset an approximate distance of 10 feet south, southwest. Two additional holes were advanced, designated as A-10 and A-12, to further establish the correlation between the surface and subsurface surveys. These holes when drilled were found to be staked off-center of the room. At this time, additional survey information is recommended to establish the relationship of the subsurface and surface surveys. The additional survey should include the advancement holes C-55 and C-57, and a correction to the surface survey as it relates to the subsurface survey should be made.

Survey confirmation hole A-7.
